TYGER®

T1 | SOFT ROLL-UP TONNEAU COVER

For HONDA RIDGELINE

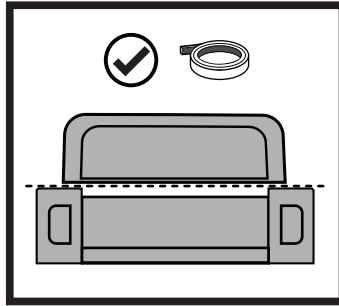
1 APPLYING SEAL STRIPS ⓘ

IF THE TRUCK'S FRONT BED RAIL IS LOWER THAN THE SIDES, USE THE PROVIDED WEATHER SEAL STRIPS. GAPS ON THE FRONT BED AND TAILGATE CAN CAUSE NOISE AND FLAPPING ISSUES WHILE DRIVING ALONG WITH WATER LEAKAGE.

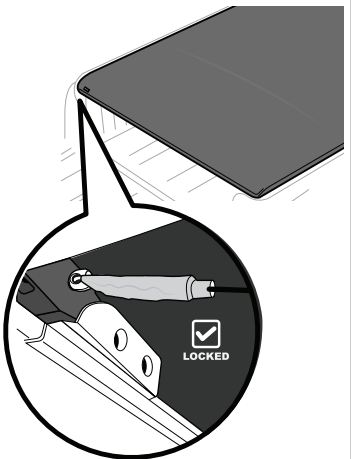
- ## 16
- MAKE SURE THE LOCKING CLIP ON BOTH SIDES ARE INSERTED INTO THE CHANNEL ON THE SIDE RAILS.
