TYGER T1 BED COVER POP-UP TROUBLESHOOTING

Please follow this troubleshooting guide if you come across any issues with the latching mechanism such as **a)** latch won't fasten **b)** loose grip **c)** latch popping out while vehicle is idle or traveling.

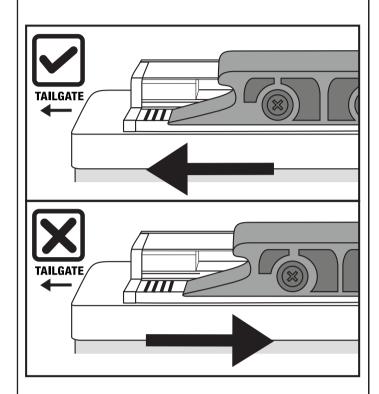
Cause:

Gap between latch head and tension plate is too wide.

NOTE: DO NOT ADJUST TENSION PLATE BEYOND THE LAST INCREMENT LINE.

Solution:

Adjust tension plate incrementally for tighter grip.

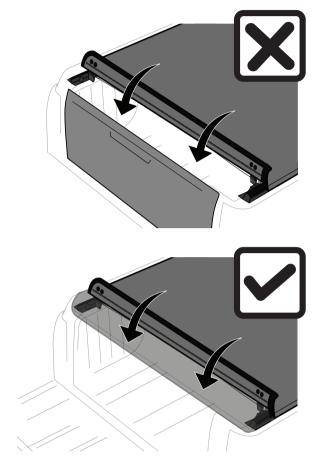
Cause:

Tailgate is closed before fastening the cover.

Solution:

Leave tailgate open, close the cover, then close the tailgate.

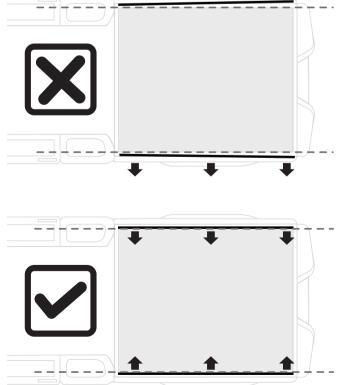
Cause:

Shifting of side rail over time may offset latch positions.

Solution:

Realign the side rails to improve latch grip.

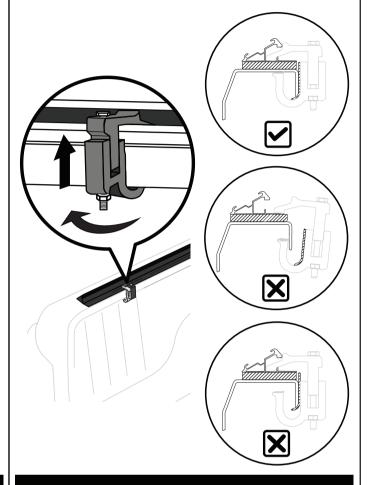
Cause:

Loose side clamps cause shifting of cover from wind drag resulting in loosened latch.

Solution:

Readjust the side clamps for tightest fit.

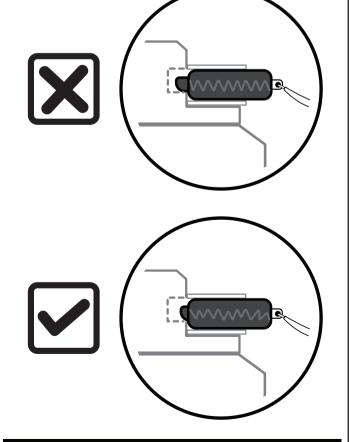
Cause:

In rare cases, fatigue in spring may occur over time reducing latch grip.

Solution:

Please contact our customer support at **1-866-340-3038** to acquire replacement spring part.
